# 8<sup>TH</sup> ARMY AVIATION TRAINING INFORMATION

**PURPOSE OF THIS TRAINING  
MODULE IS TO INFORM  
ARMY AVIATION LEADERS  
OF  
FACTORS INVOLVED IN  
RECENT KOREA ACCIDENTS  
AND PREVENTION  
MEASURES**

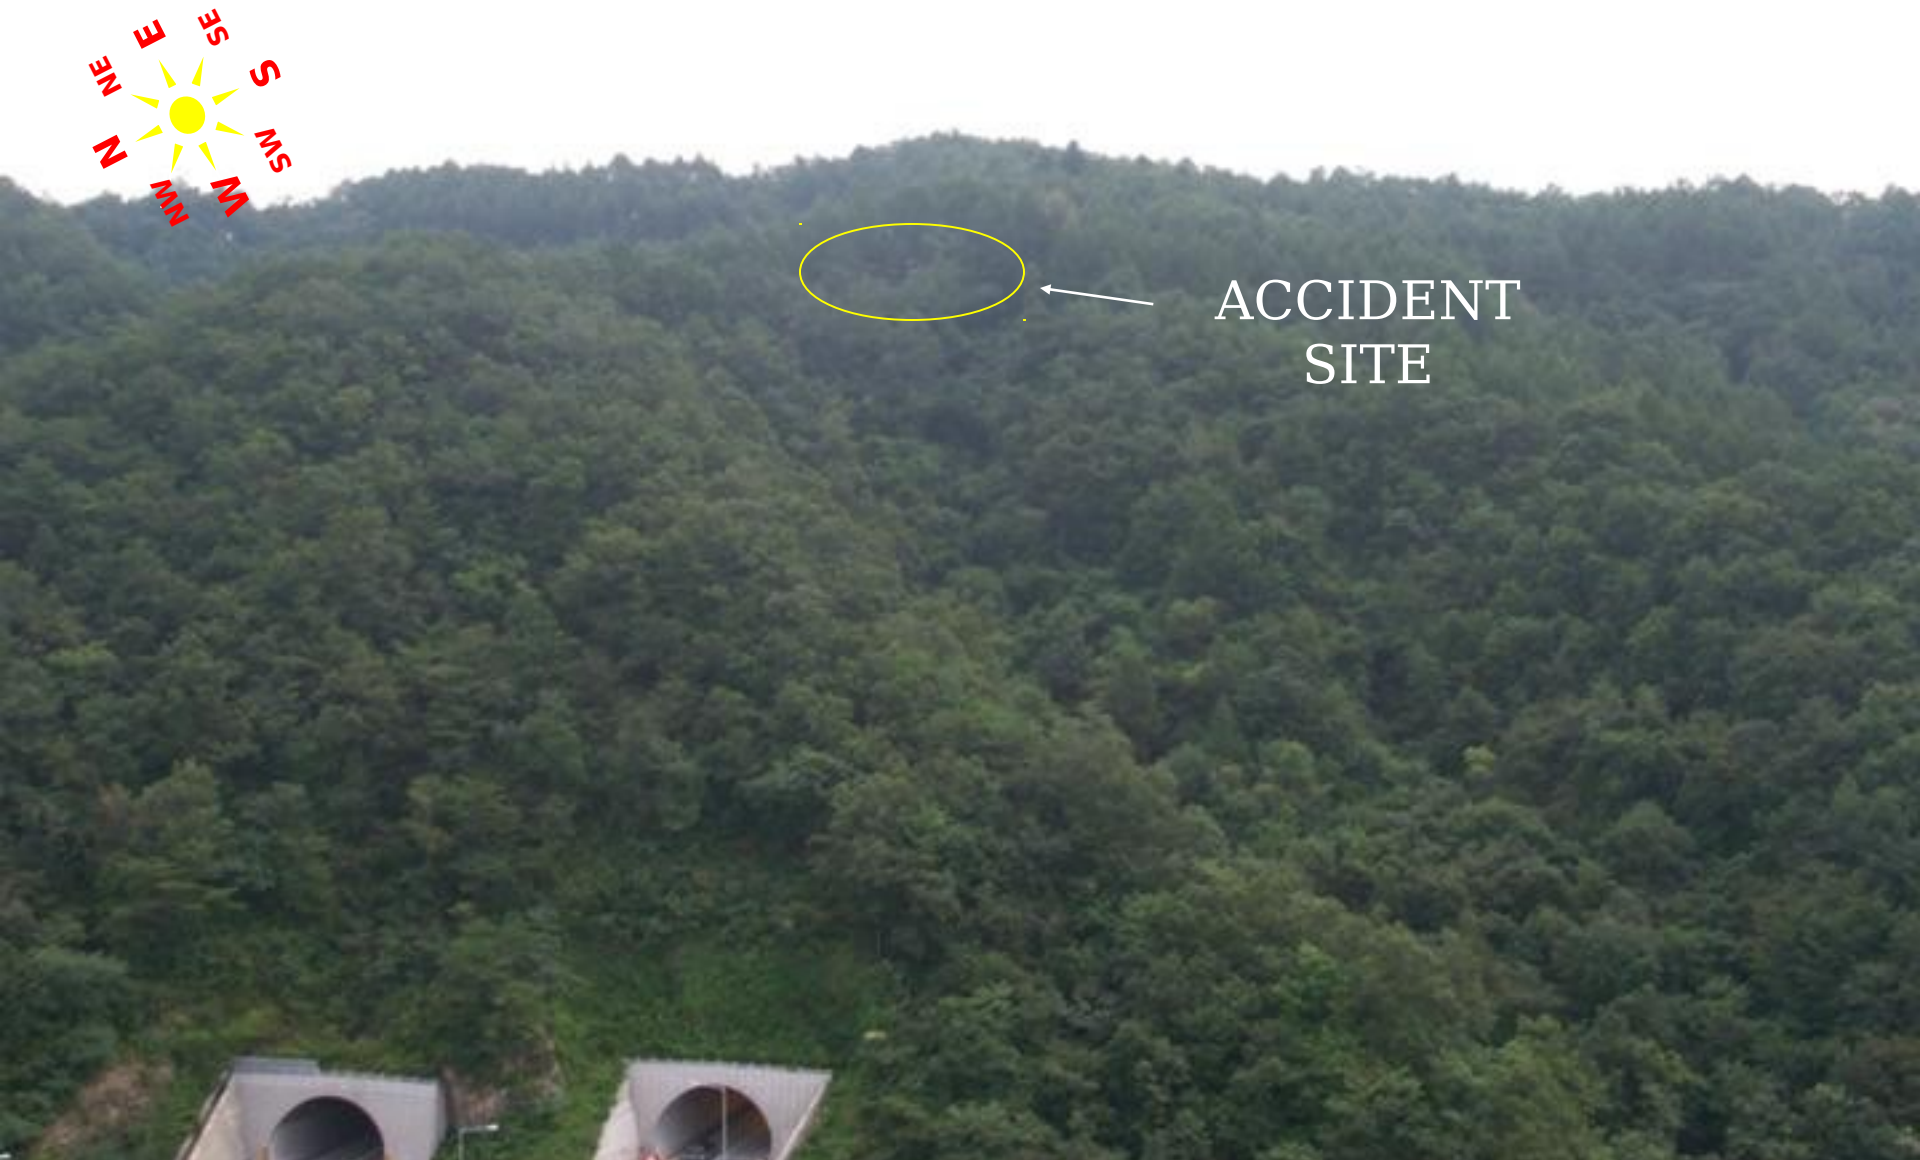
ACCIDENT  
SITE

**Aerial view looking at the approximate flight path.**

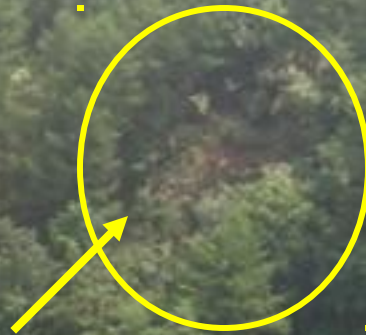
**Flight  
Path**

**Aerial view looking East.**

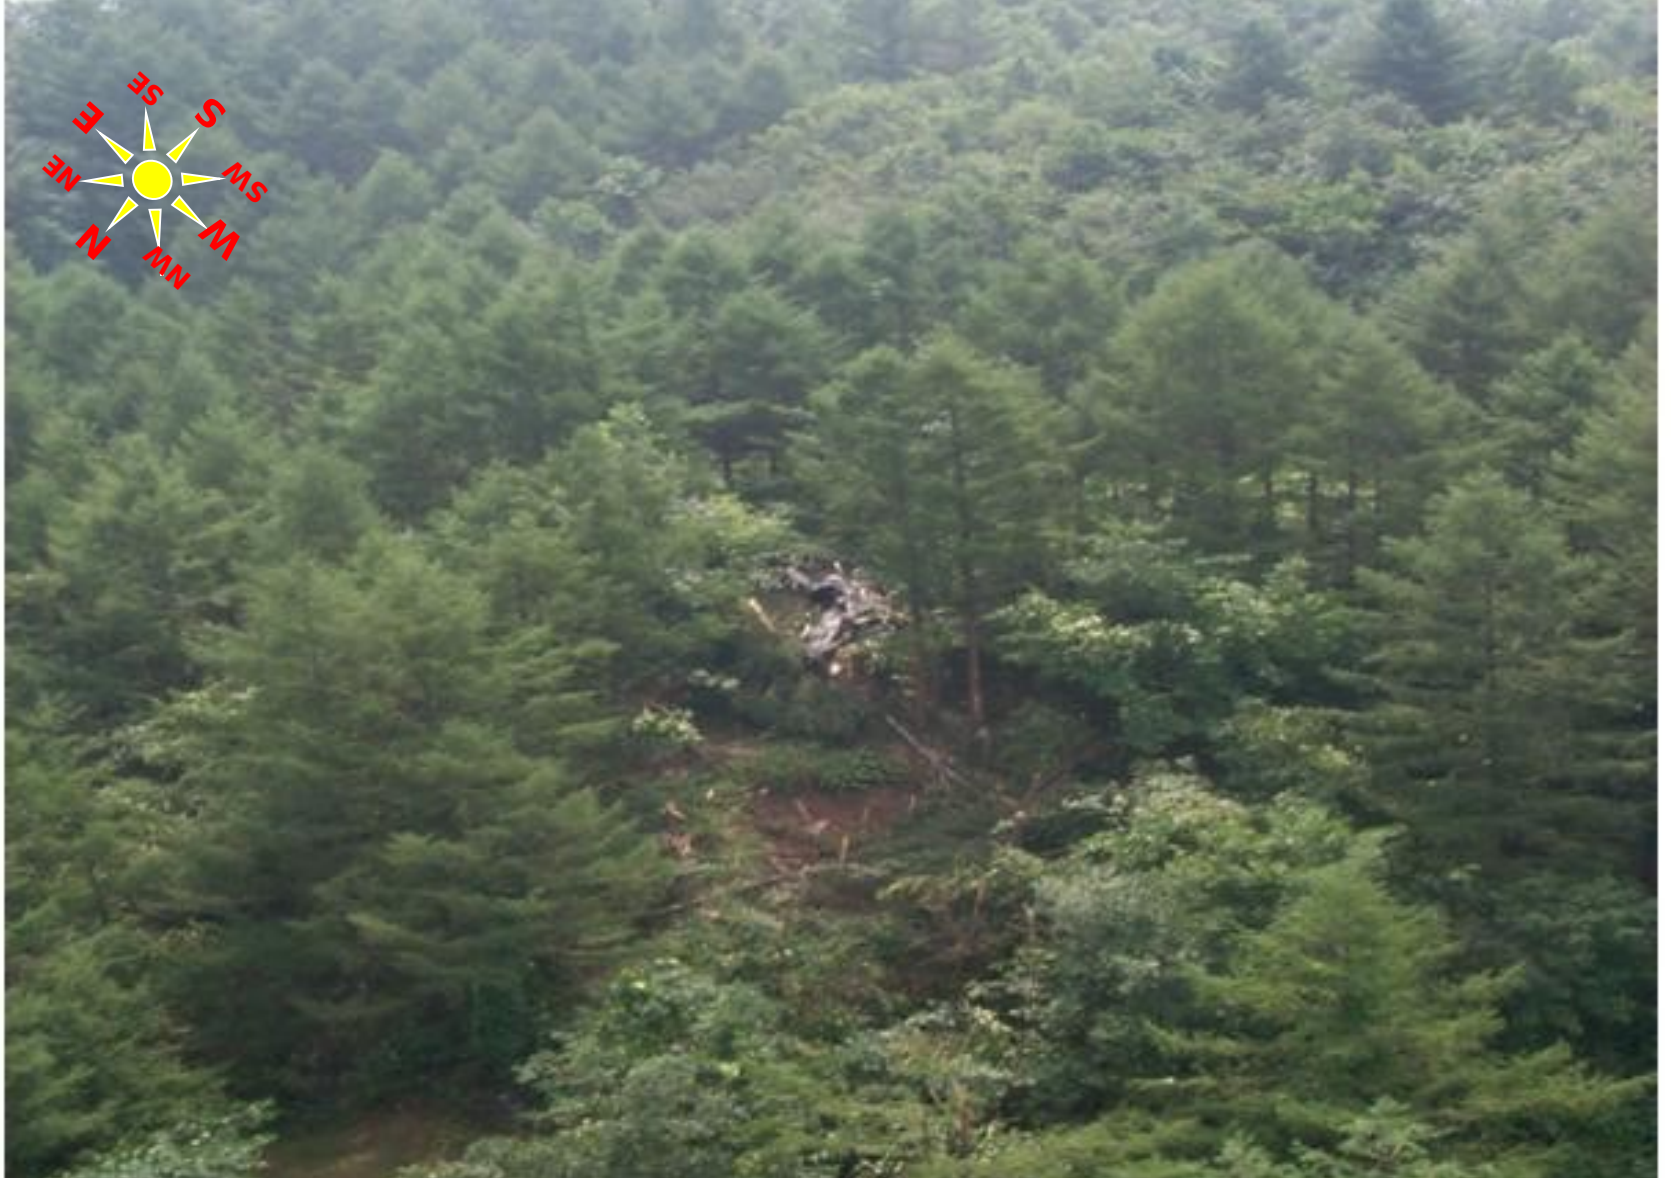
view looking just above the approach path on a heading of 45°. Elevation at initial ground impact is 885' M

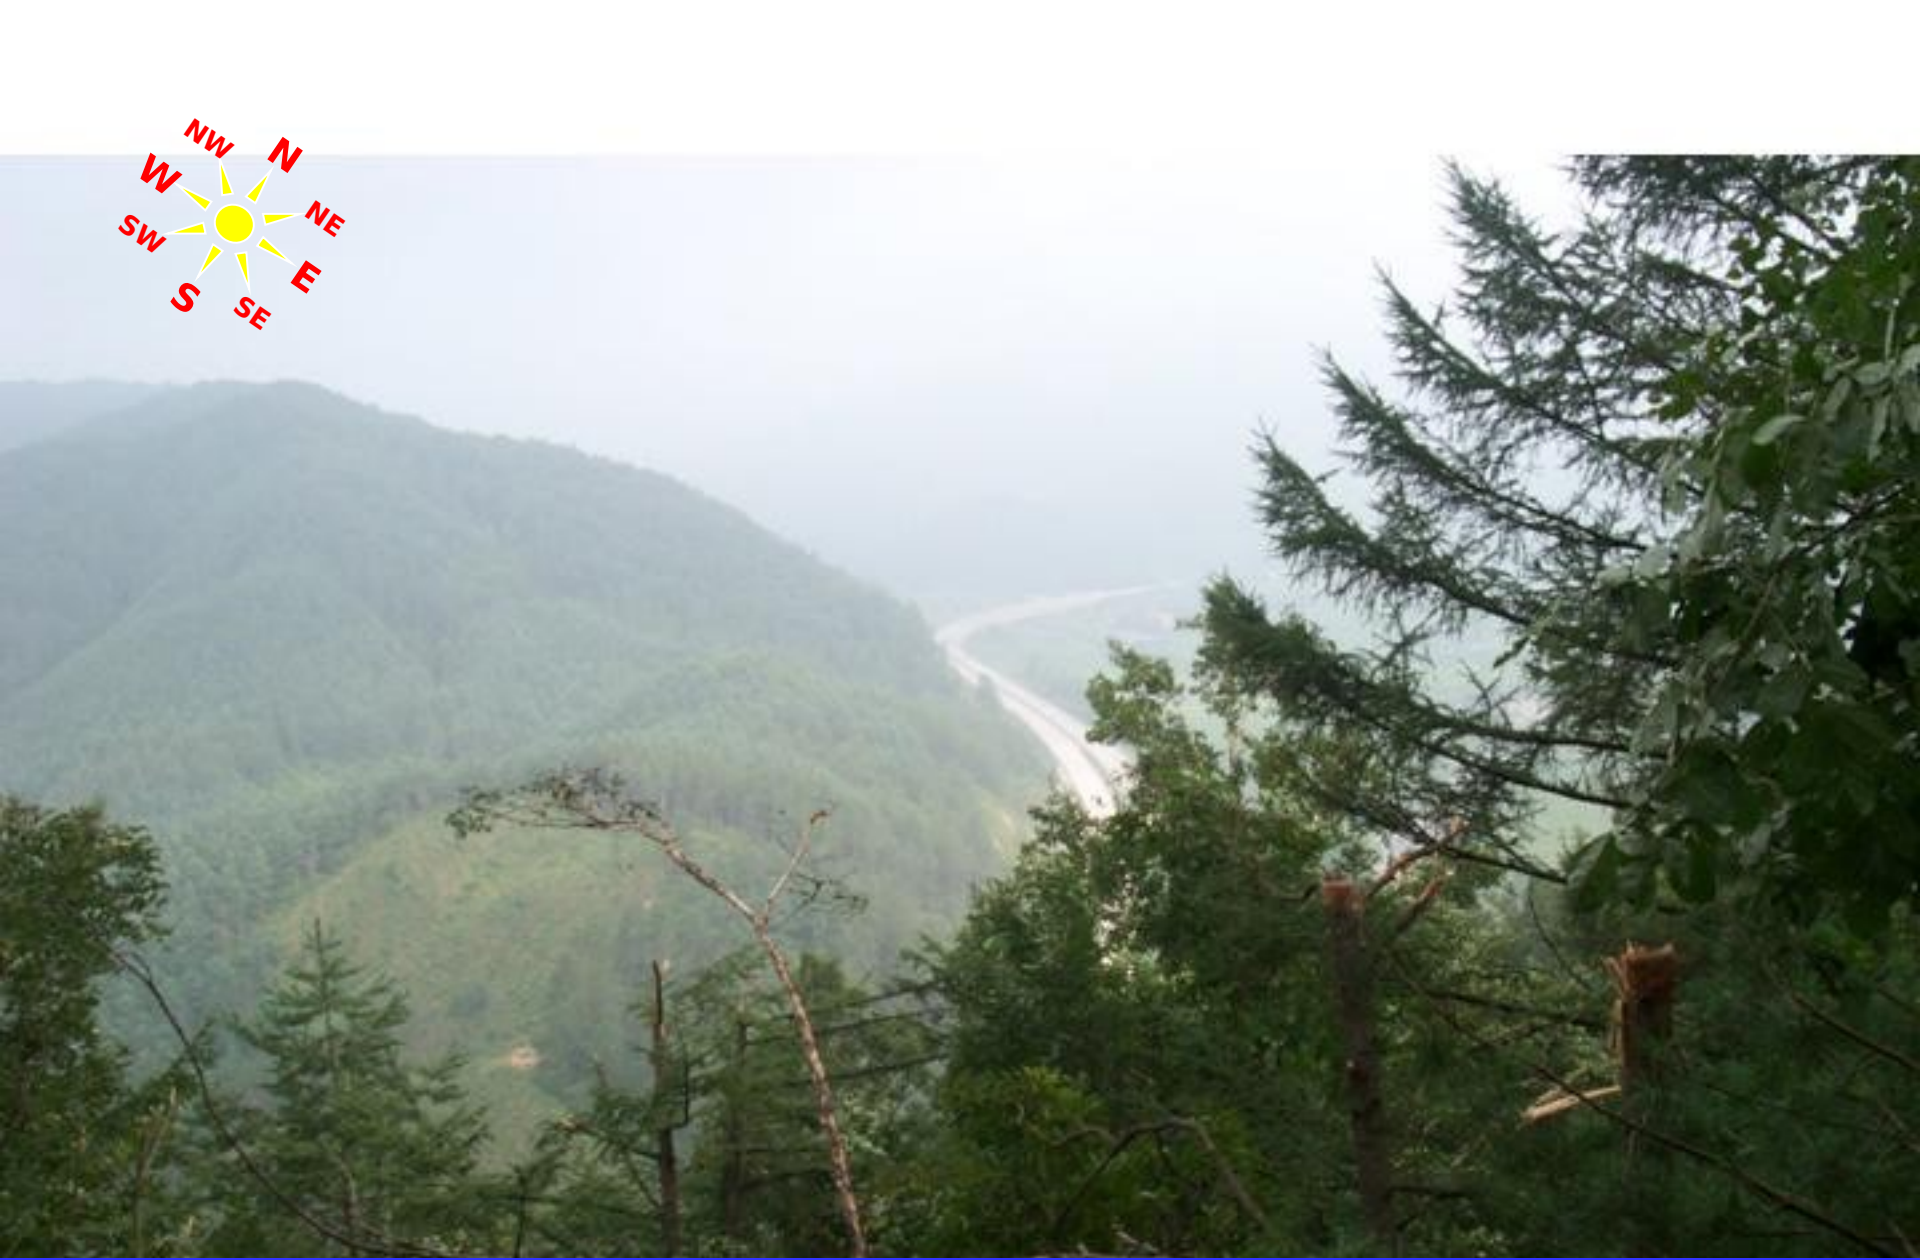
ound view looking back at the flight path . Distance from  
first tree strikes to ground impact is ~100 feet.

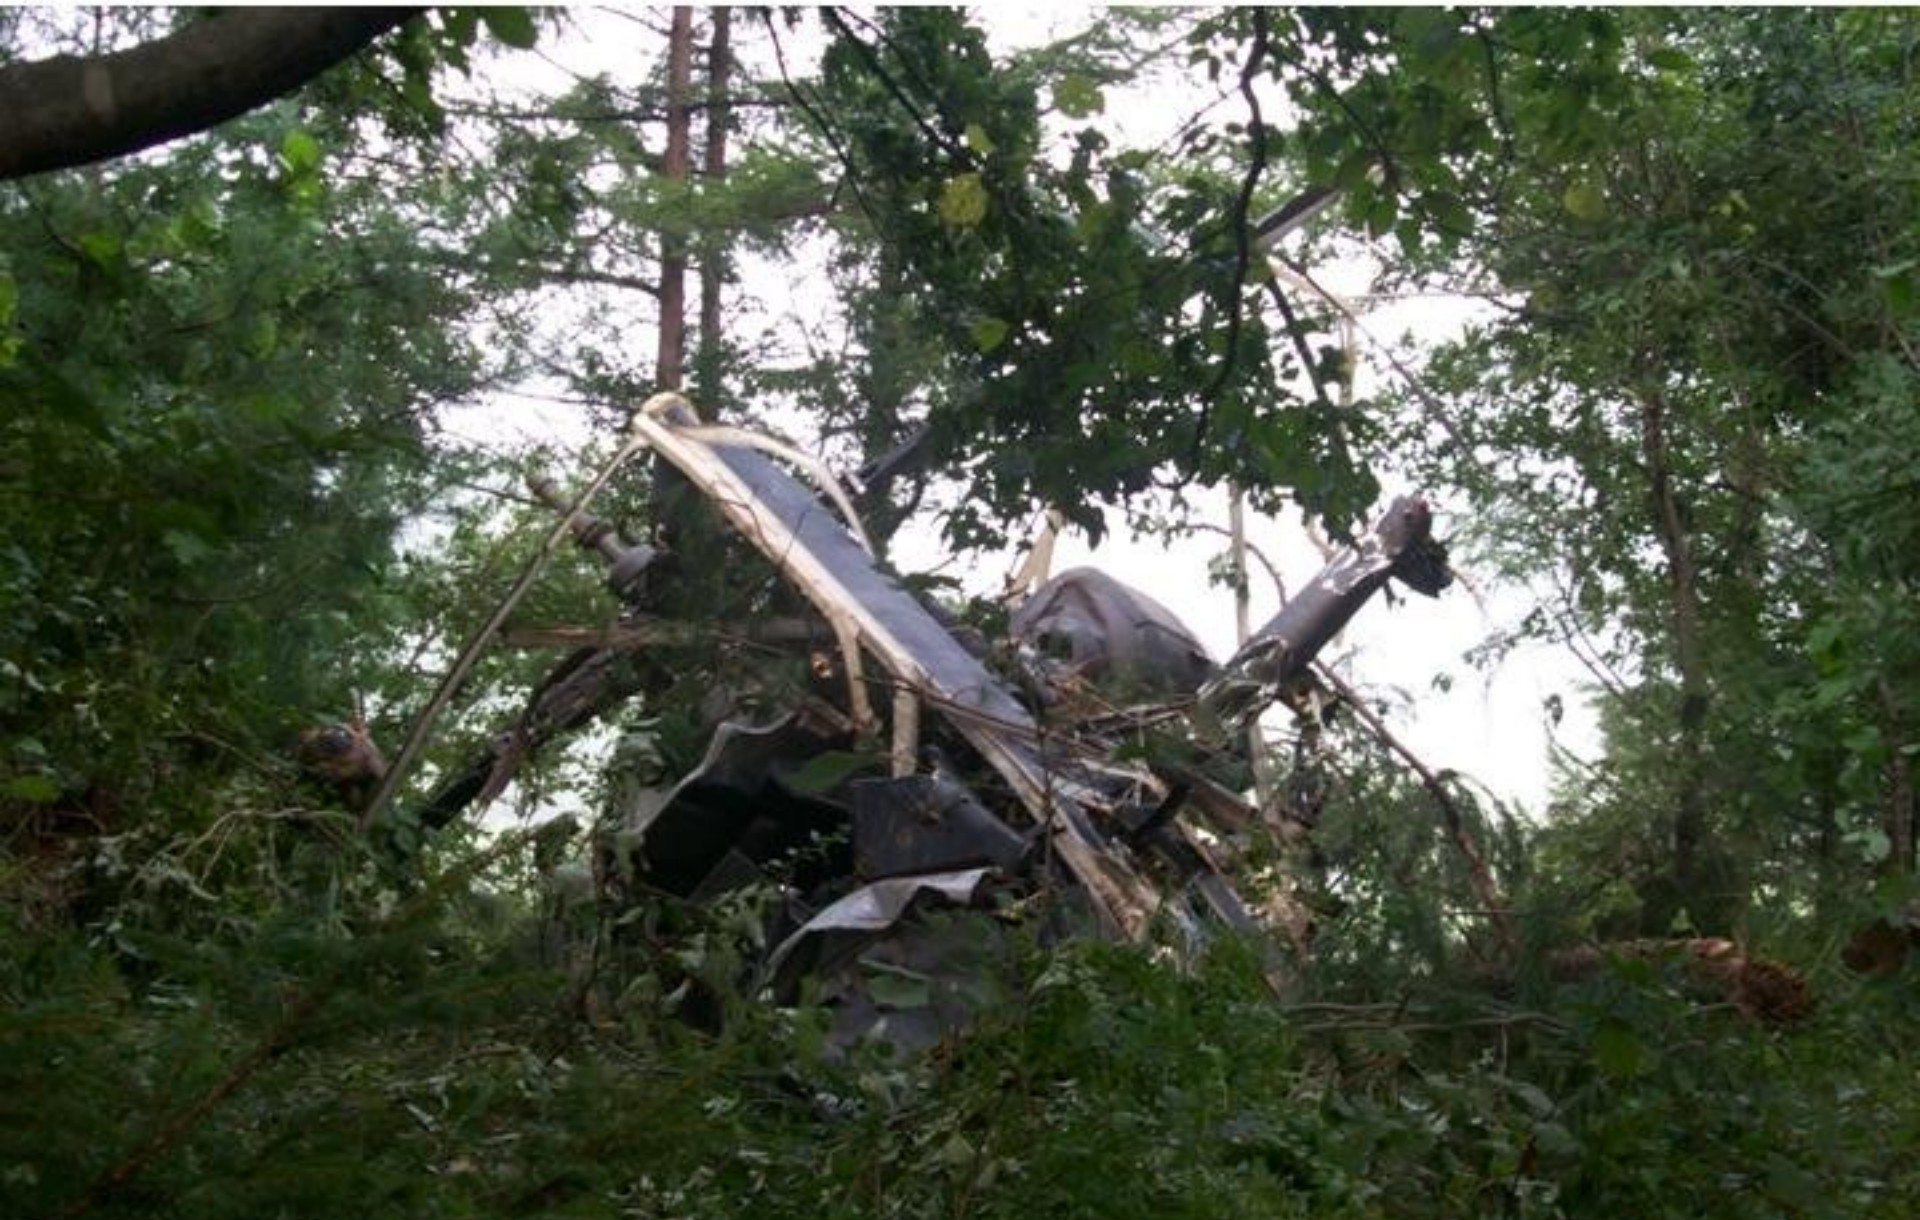
**Close up of aircraft wreckage. Aircraft came to rest in  
up and  $\sim 40^\circ$  right roll attitude 83 feet from ground**

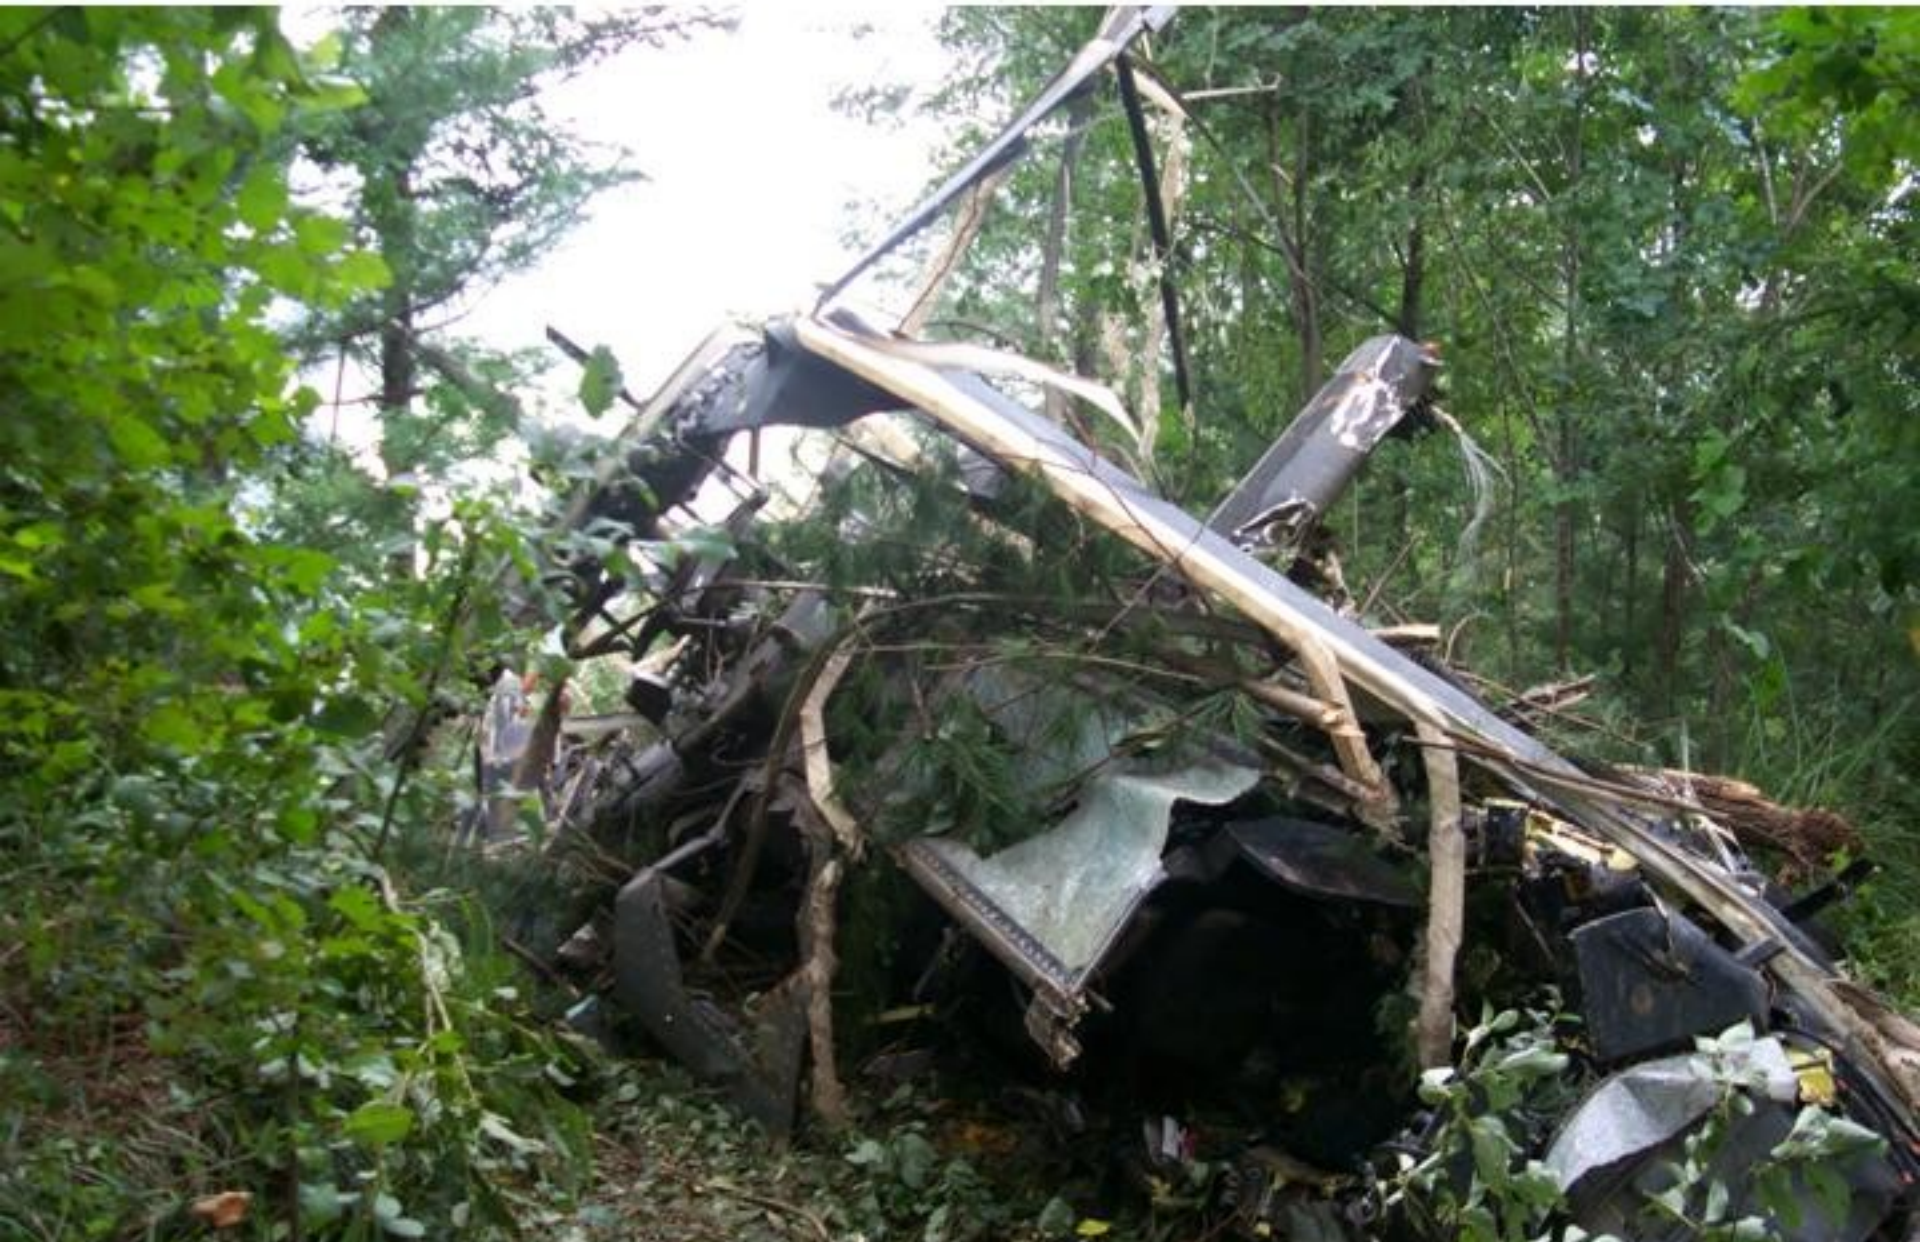
**Aircraft struck an 11" diameter tree with the aircraft nose at point**

**6 feet below the tree top and 16 feet below the tree base**
